## Accident Information Report

1. Name of the Police Station: Kalimpong PS (Reang P.P.)
2. CR. No. /Traffic Accident Report: Kalimpong PS Case No.206/22 dtd.29.07.2022 U/S 279/338/304(A)/427 IPC.

Photograph of Vehicle bearing registration no  
**WB 79 A 2942 HONDA GRAZIA**

## MECHANICAL EXAMINATION REPORT

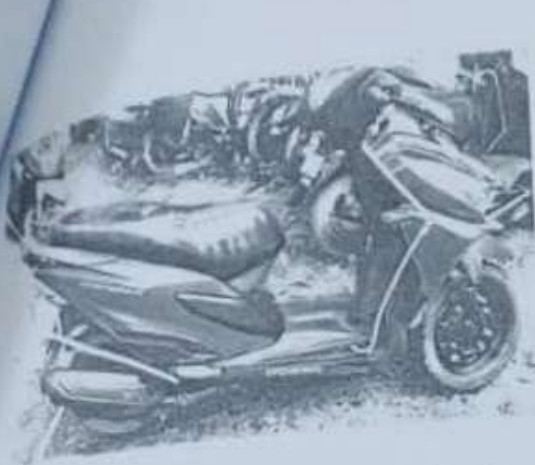
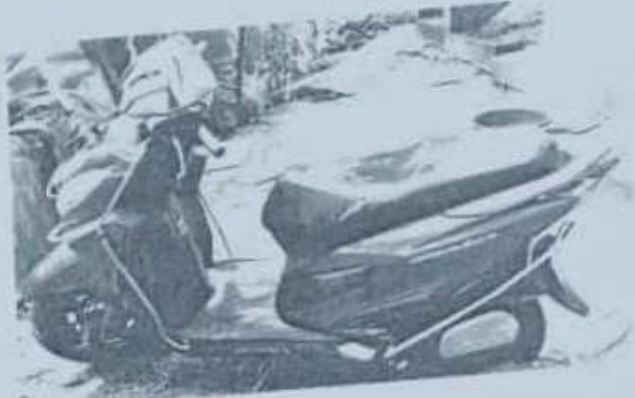
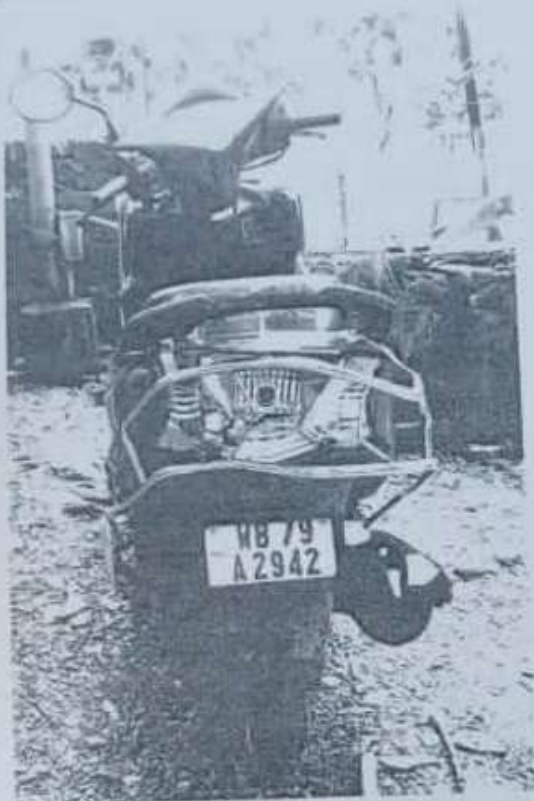
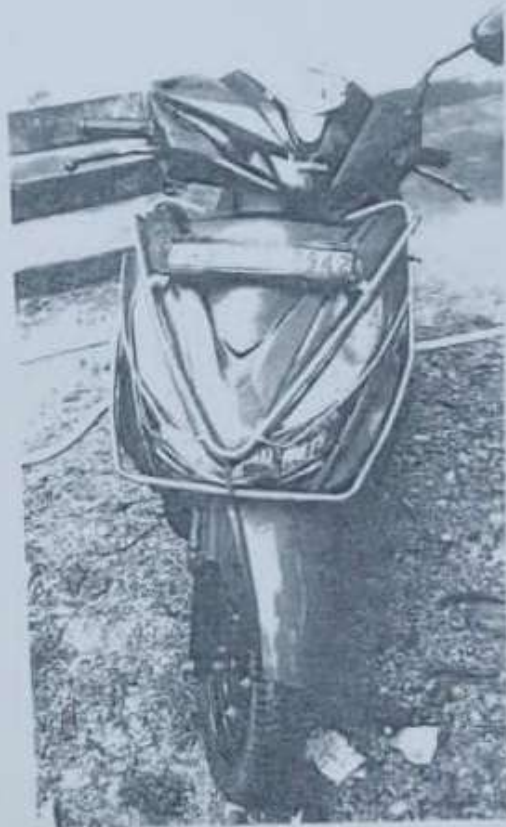
Rear portion of scooty body, guard, left side of scooty body is badly damage and rear brake and indicator light, right side of sideview mirror is broken .

- The 3a reflector sticker is not fitted on the rear portion of scooter body .

From the Technical point of view the cause of accident of the above mentioned vehicle appears to be other than mechanical failure .
