#### Accident Information Report.

MECHANICAL EXAMINATION REPORT

Case No. / M.A Case No.: 191 / 2022. Dated. 12-07-2022. U/S, 279 / 337 / 338 / 427 . IPC.

**Photograph of Vehicle bearing registration no  
SK 07 D 0309 TATA ULTRA TRUCK**

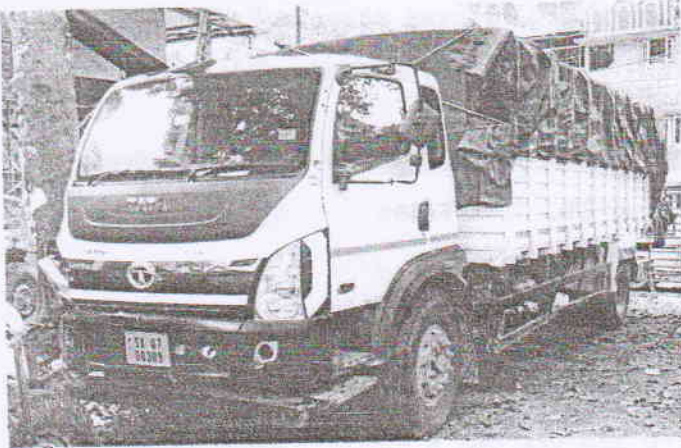
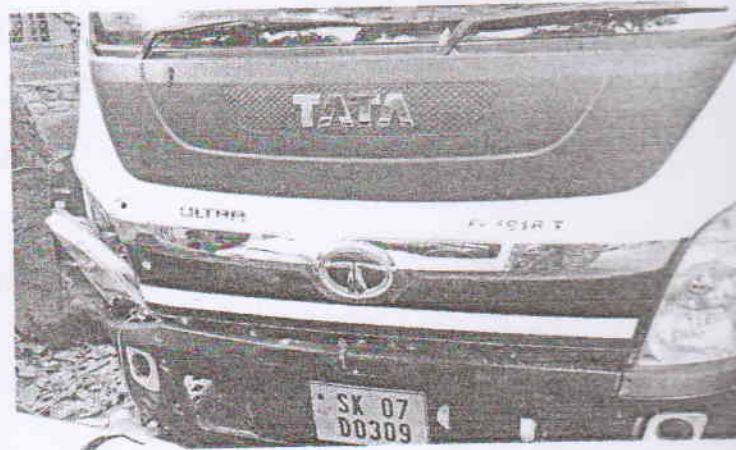
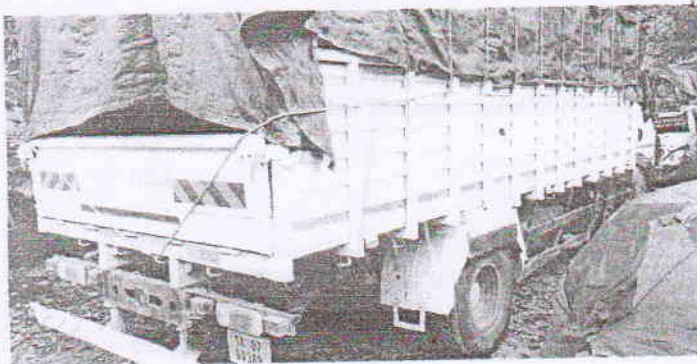
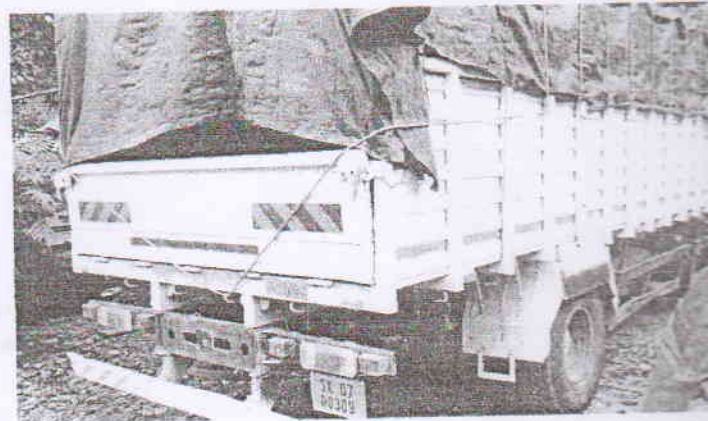
Front right side show, bumper, mudguard, door is partly damage and front right side head and indicator light is broken .

Light's are working properly . Except front right side head and indicator light due to accident .

From the Technical point of view the cause of accident of the above mentioned vehicle appears to be other than mechanical failure .
